2_35 COMPLETING TEMPLATE TRANSITIONS

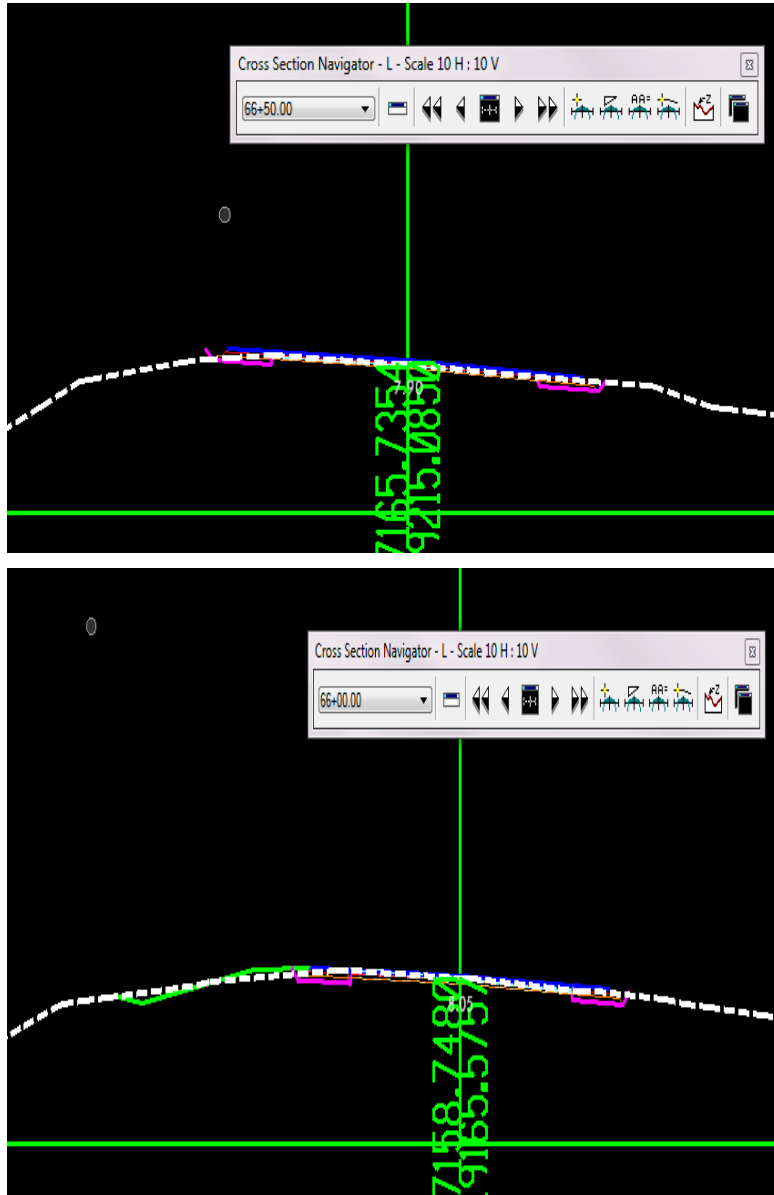
The last two cross sections are missing the side slopes. What is causing this issue?

The cross sections (as shown above) then will not have the missing side slopes drawn. This is similar to the case as described in the below link.

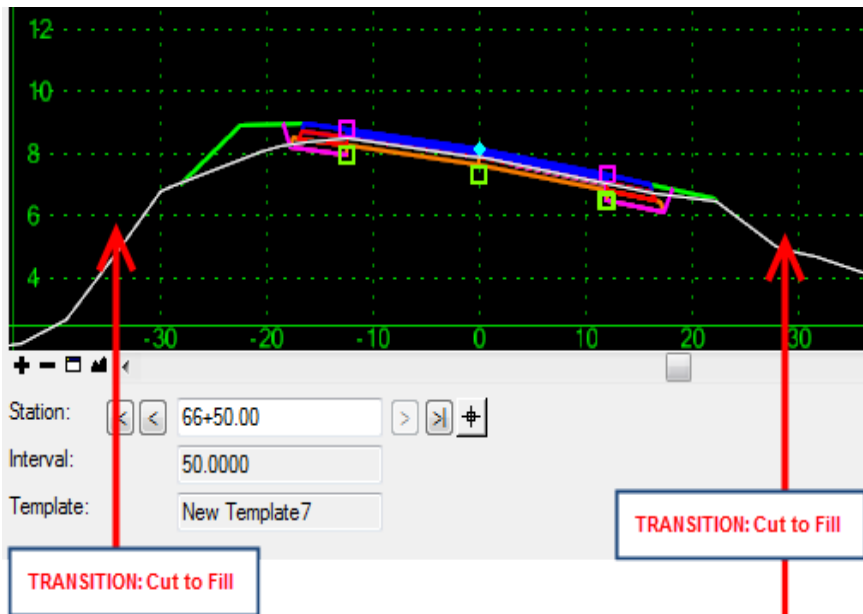
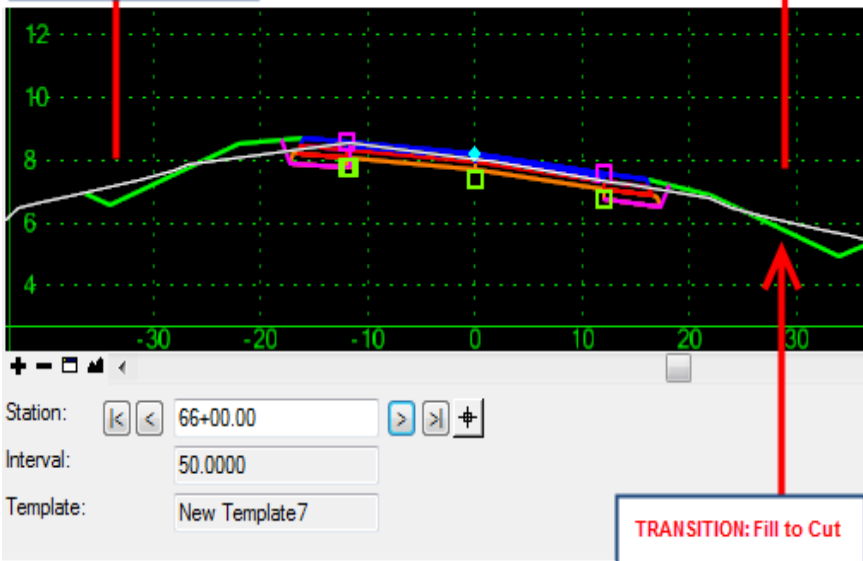
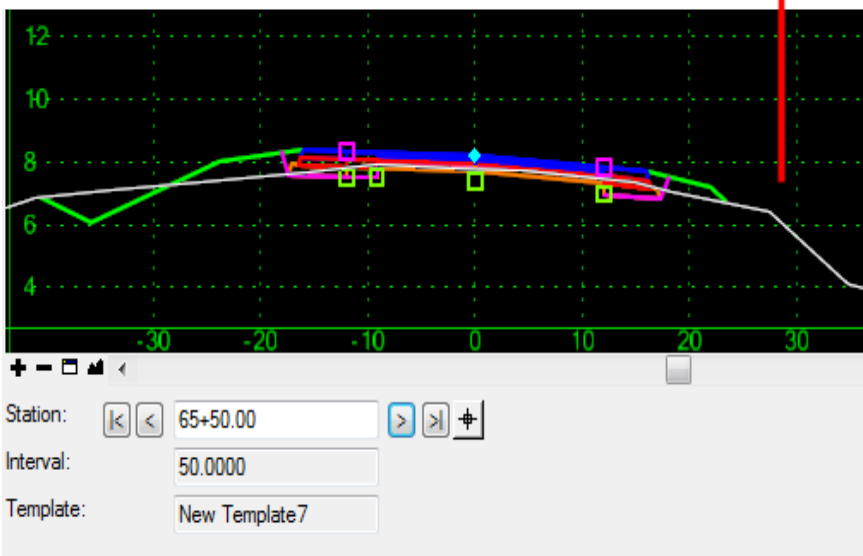
Since cross sections are cut from the DTM, and the DTM is created from the template drops, the source of the problem can be directly traced to not completing the template transition in Roadway designer. Starting at station 65+50 (bottom) to ending station 66+50 (top), the right side is continuously transitioning **C** → **F** → **C**. The left side is transitioning at the last two template drops **C** → **c** → **F**.

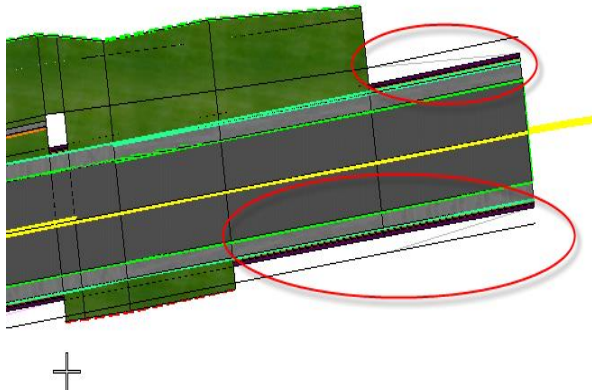
When creating a surface from these 50' template drops, the DTM will likely to contain “gaps” because of not completing the transition.

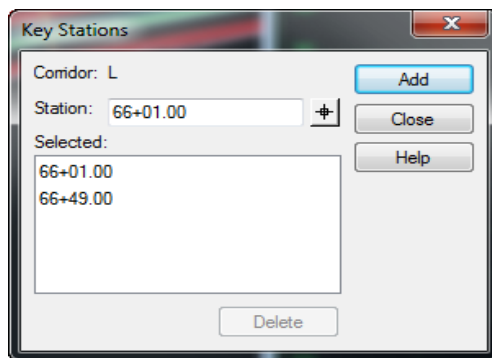
To resolve templates in a constant transitioning states, two “liked” templates drops must precede each other. Use the “Key Stations” feature in Roadway Designer and add a template drop near the cross section having DTM gaps. Although not 100% guaranteed, the likelihood of two template drops transitioning from Cut to Fill or vice versa is greatly reduced by having them in close proximity to each other.

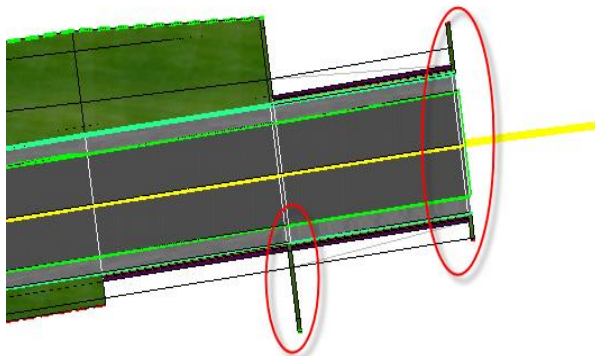
The resulting DTM surface (small but adequate to cut cross sections from).
